# Manhole Inspection Summary

Manhole # S43I\_\_011MH

Insp Date: **4/30/08 10:55 AM**

**Location** Address: **432 Eastern av**

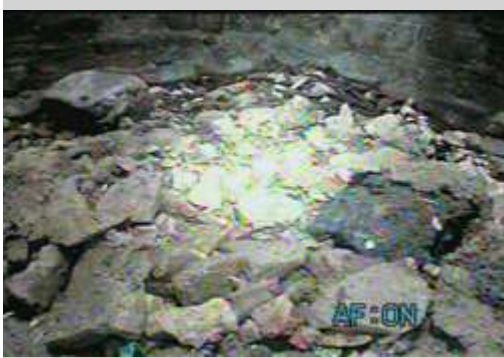
Defect 3

Condition: ☐ Sound ☐ Cracked ☐ Root Intrusion ☐ Deteriorated ☐ Leaks ☒ **Debris**

bench debris

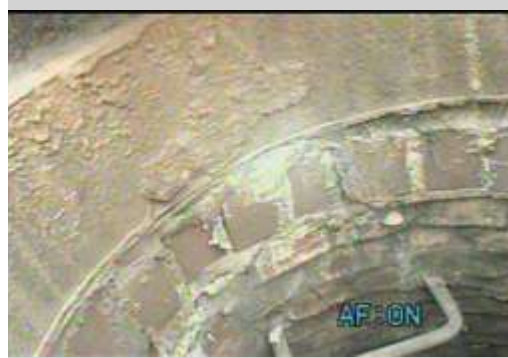
Defect 2

Condition: ☐ Sound ☒ **Cracked** ☐ Root Intrusion ☐ Loose Brick ☐ Deteriorated

cracked chimney

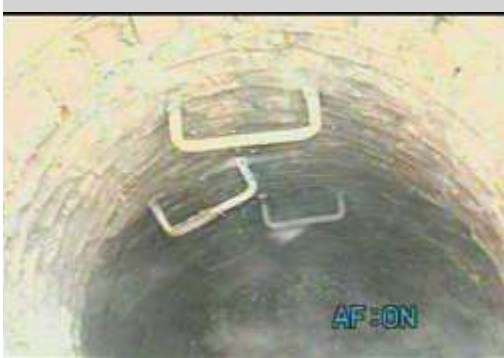
Defect 1

Count: **5** Missing: **0** ☒ **Corroded**

corroded steps

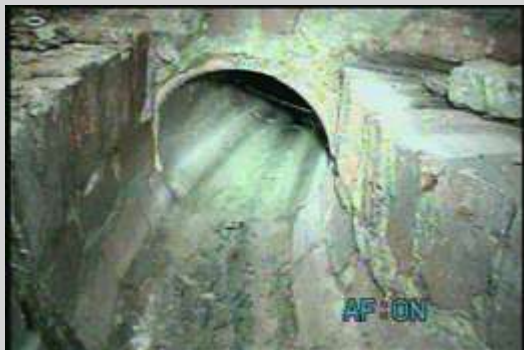
12 O'Clock Outflow

10 in. Circular Gravity Sewer  
Pipe Out @ 12 OClock

Pipe Material: Clay ☐ Pipe Lined

Invert Depth: 9.50 (ft.) Flow Characteristics: Fast

Deposits: ☒ None ☐ Mud ☐ Sludge ☐ Debris ☐ Grease

Infiltration: None Pipe Seal Cond: Unknown

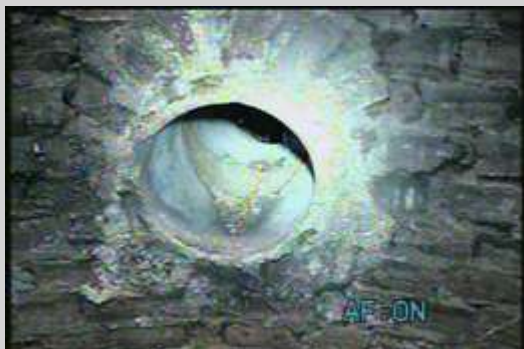
3 O'Clock Inflow

10 in. Circular Gravity Sewer  
Pipe In @ 3 OClock

Pipe Material: Clay ☐ Pipe Lined

Invert Depth: 7.75 (ft.) Flow Characteristics: Fast

Deposits: ☒ None ☐ Mud ☐ Sludge ☐ Debris ☐ Grease

Infiltration: None Pipe Seal Cond: Unknown

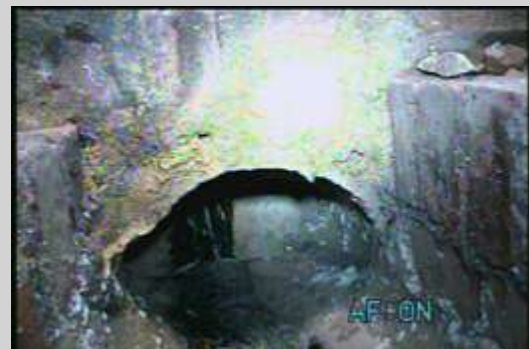
Drop In @ 3 OClock

Drop: Outside Direct

Inv Depth: 9.33 (ft.)

Drop Condition: Open
